UNITED STATES COAST GUARD

MARINE SAFETY ALERT

Safety Alert 03-26

IMMERSION SUIT MAINTENANCE AND INSPECTIONS

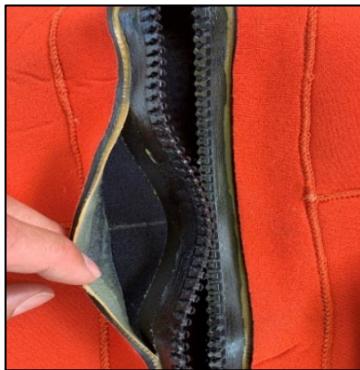
U.S. Coast Guard (USCG) inspectors frequently find immersion suit defects caused by adhesive failures between the main zipper and the suit body. These failures, illustrated in Figures 1 and 2, compromise watertight integrity and pose serious survival risks from water ingress. Contributing factors to the defects include improper maintenance (e.g., the use of non-approved petroleum-based lubricants or scented powders), improper storage, and neglecting to conduct periodic pressure testing. Seam and closure deterioration may not always be detectable during routine visual inspections. Adhering to USCG regulations, manufacturer instructions, International Maritime Organization (IMO) regulations and guidance, and performing regular inspections and testing are essential to ensuring immersion suit reliability.

Figure 1: Zipper failure due to glue separation.

- Conduct thorough inspections of all immersion suits, focusing on zipper-to-body seams and seam-taped areas such as boots, gloves, and hoods. Check for signs of delamination, seam tape lifting, adhesive failure, and zipper malfunction. Verify zipper function and proper lubrication using only manufacturer approved products.

- Store suits with zippers fully open and use monthly inspections as opportunities for crew donning practice.
- Conduct air pressure leak testing at least every three years, or at more frequent intervals for suits over ten years old.
- Address any identified defects immediately and ensure repairs are performed by an authorized repair station in accordance with manufacturer instructions and remove non-functional suits from service.
- Replace any suits that cannot be restored to a watertight condition to the satisfaction of the vessel's Flag Administration.
- Update maintenance procedures to ensure manufacturer directions are followed and only manufacturer-approved products are utilized to service and maintain equipment.
- Maintain detailed records of inspections, tests, defects, repairs, and replacements.

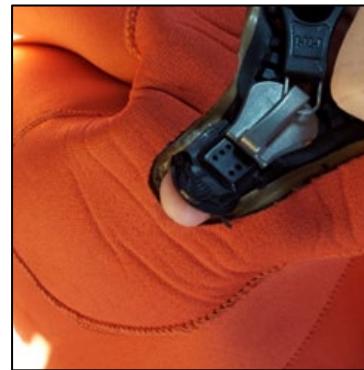
Figure 1: Bottom of zipper failure due to glue separation.
